RAILWAY INVESTIGATION REPORT

R02T0149

CROSSING COLLISION

VIA RAIL CANADA

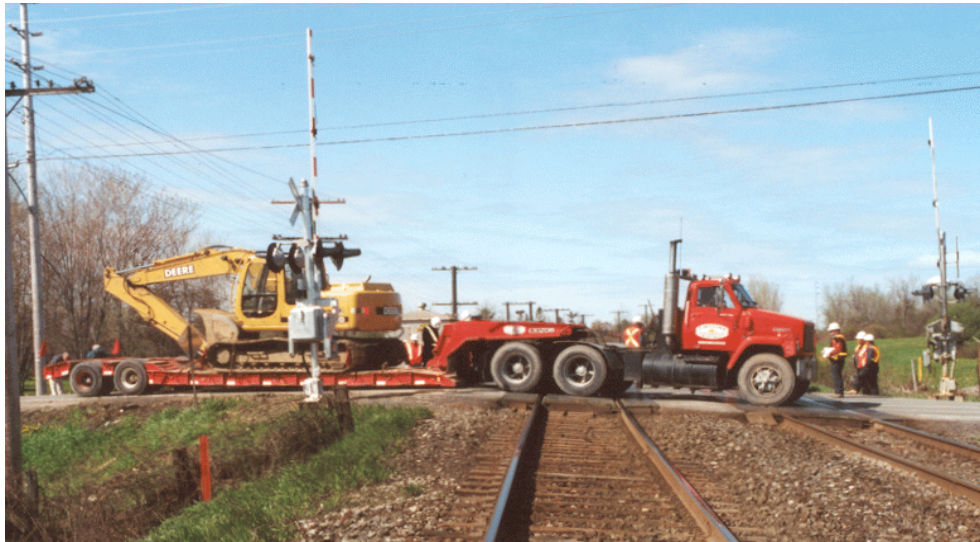
The vehicle operator contracted for the simulation was instructed to drive over the crossing in both directions, with the trailer at the normal driving height, prepared to stop on command. In both directions, the trailer made contact and came to a stop on the asphalt roadway surface south of the railway tracks. It was subsequently only able to proceed after the trailer was raised. In both directions, the tractor-trailer combination was foul of both main tracks.

- There was nothing unique about the vehicle involved in the accident that would have differentiated it from the thousands of other similar vehicles travelling on North American roadways. The trailer's ground clearance and wheelbase were typical for this unit type.
- Based on scale drawings and the simulation test, it was considered that the bottom of the accident trailer could have contacted the roadway.
- It was not determined whether the tractor would have had sufficient power and traction to successfully pass through the crossing with the bottom of the trailer dragging on the ground.

Figure 1. Simulation of truck crossing the tracks at point of grounding out
